ProTECT68 PRESSURE CONTROL KIT

1030362 2007-2018 68RFE Transmission

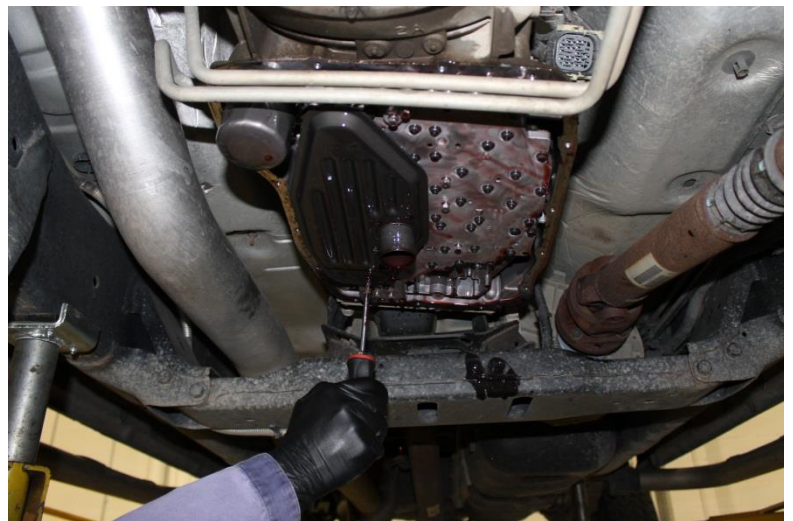
10. Remove transmission filter by removing the one T25 Torx screw.

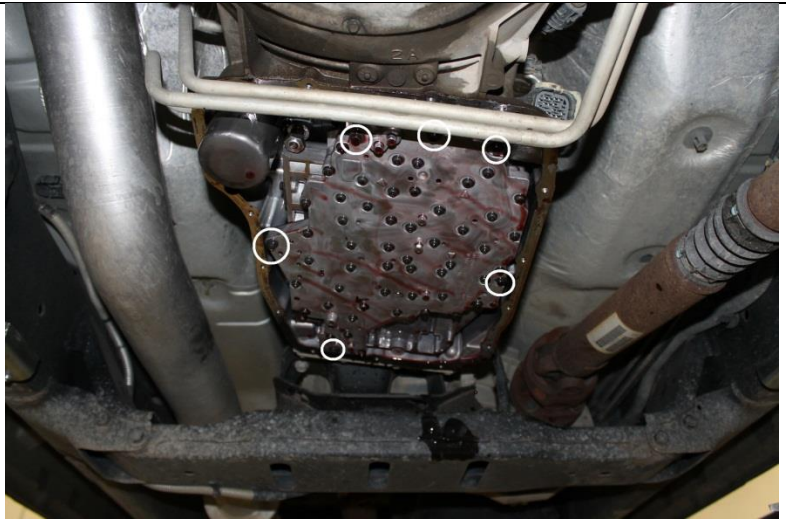
11. Remove the six 8mm bolts securing the valve body to the transmission. Drain valve body of fluid. To remove valve body from transmission, wiggle it while pulling downwards to work the electrical connector through the case.

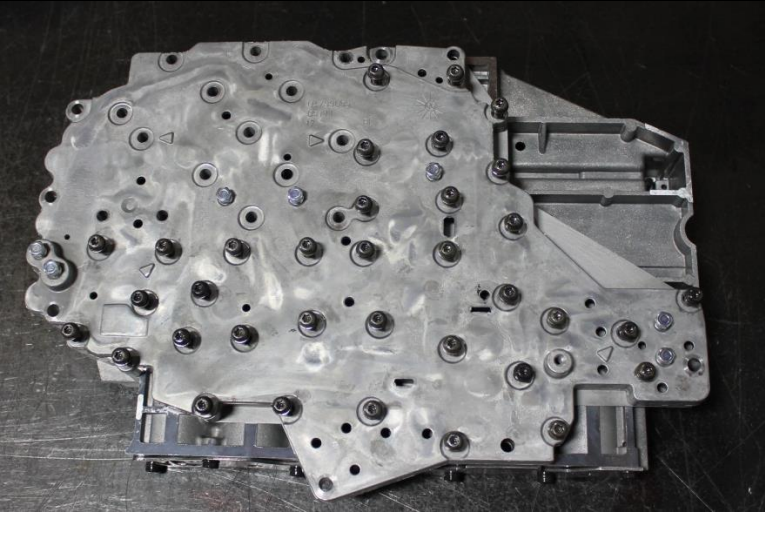
<p>24. Re-install bottom (smaller) half of valve body. Ensure it fits flat on the separator plate/gasket. It may need to be worked downwards while rocking to be installed over the dowels. Install attaching screws so they are fully seated but do not tighten until the solenoid pack has been installed.</p>

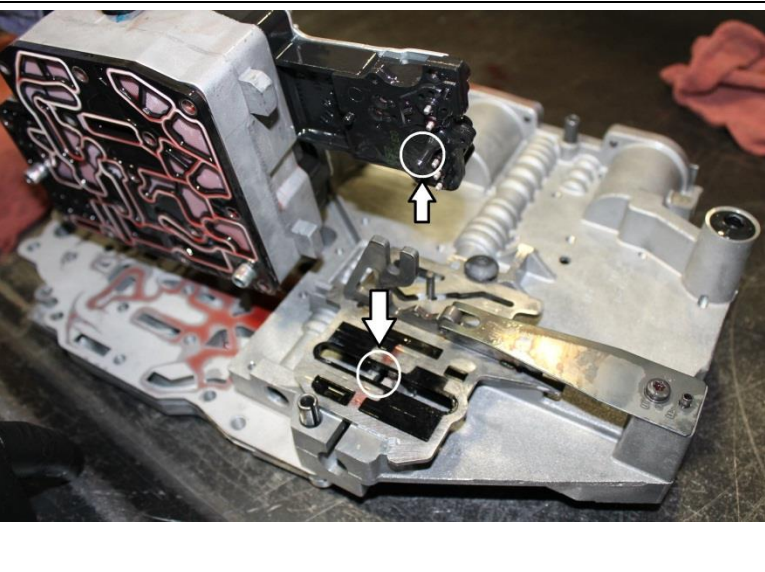
<p>25. Re-install solenoid pack onto valve body. Be sure to properly align the pin on the solenoid pack with the slot on the valve body. Due to the alignment dowels, the valve body may need to be wiggled down into position. Install solenoid pack attaching screws. Install remaining Torx screws to fasten the solenoid pack to the valve body.</p>

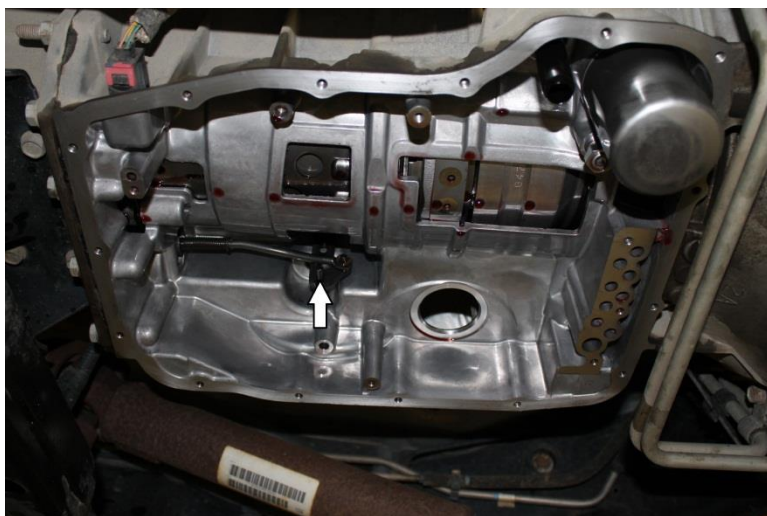
30. Check that the shift lever on the valve body lines up with the shift lever on the transmission and lift the valve body back into the transmission. Start the 8mm screws by hand, do not tighten yet. Work the shift lever on the outside of the transmission case by hand to ensure that the lever is making contact with the valve body correctly.

IMPORTANT: Use great care when reinstalling the valve body, the gasket that mates with the front of the case must line up correctly. Do not fold or pinch during installation.

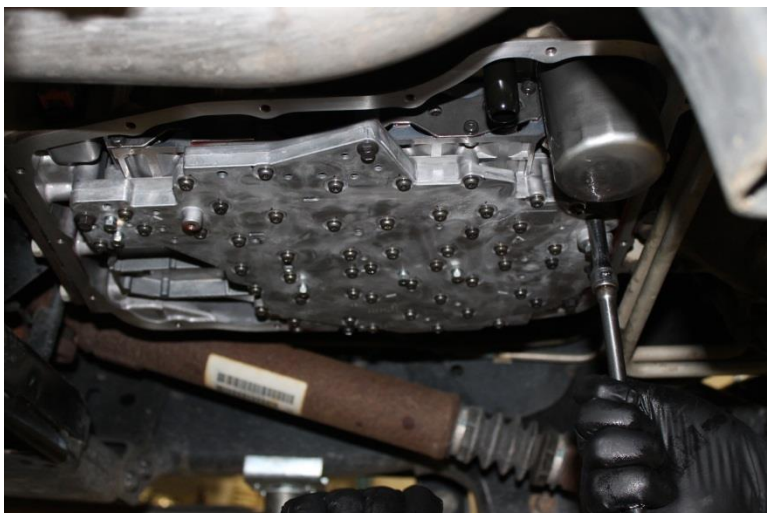
31. Torque the valve body attaching bolts to 105 in/lbs.

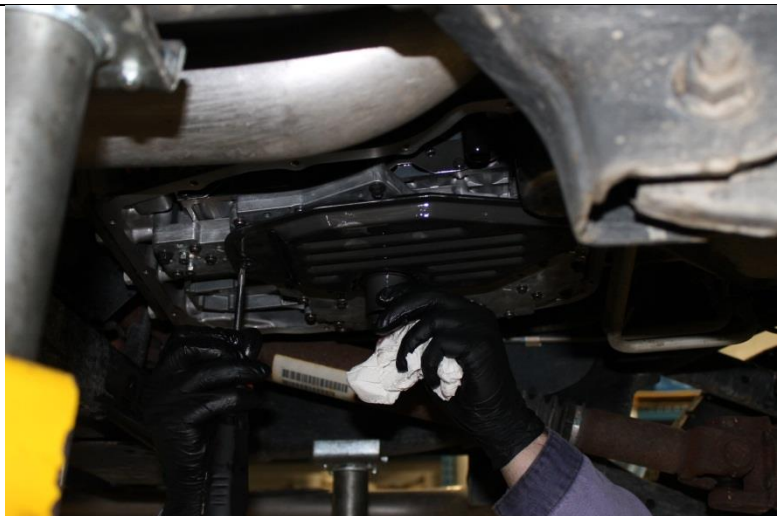
<p>32. If desired, install new filter(s). Otherwise, reinstall the filter/pickup assembly. Torque to 50 in/lbs.</p>

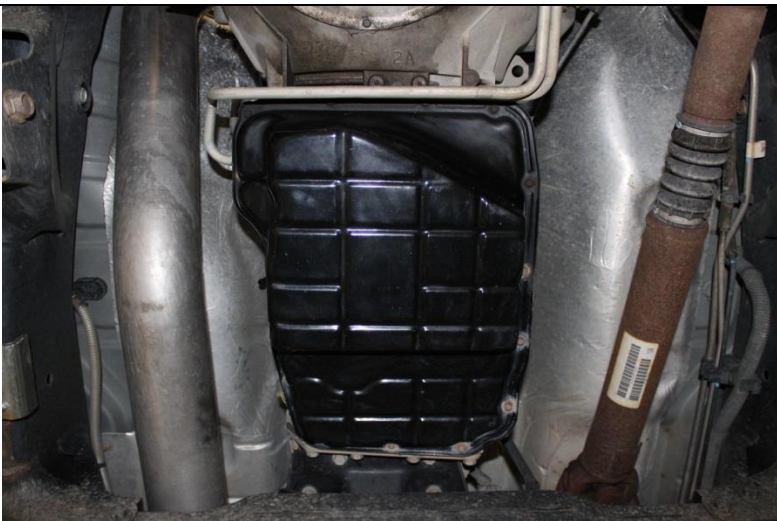
<p>33. Place the supplied gasket on the transmission pan. Hold pan below transmission and install attaching screws. Torque the pan screws to 105 in/lbs.</p>

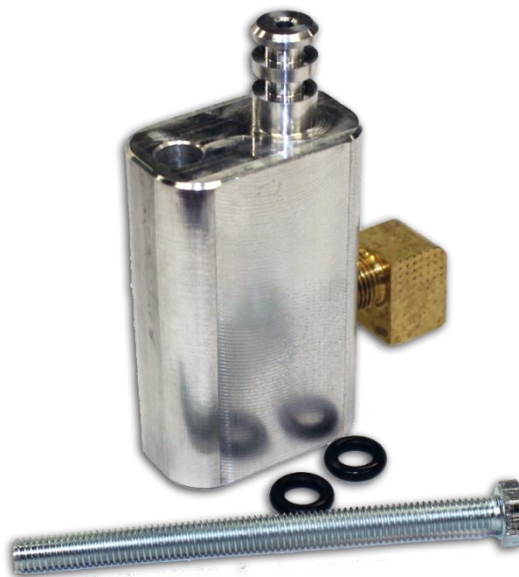
ADAPTER KIT BD# 1061529

Use this kit with a 300 psi gauge.

41. Note. If you would like to verify the increases in line pressure, use adapter kit (BD 1061529) in conjunction with a 300psi gauge. Pressures at wide open throttle should be between 240 – 260 PSI with a mechanical gauge.
